Manhole Inspection Summary

Manhole # S33EE_051MH

Insp Date: **2/24/07 11:18 AM**

Location Address: **PARK AVE**

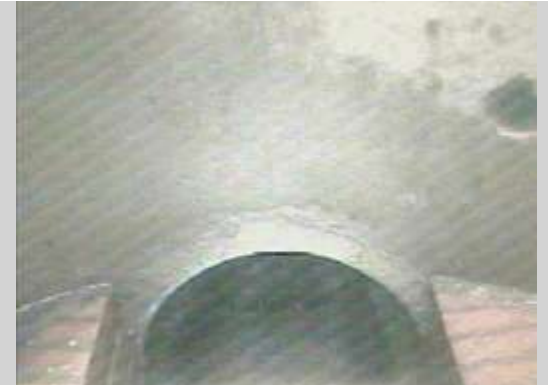
21 in. Circular Gravity Sewer Pipe Out @ 12 O'Clock

Rod and Bar (Angled)

Pipe Material: **Unknown** ☐ Pipe Lined

Invert Depth: **19.70** (ft.) Flow Characteristics: **Fast**

Deposits: ☒ None ☐ Mud ☐ Sludge ☐ Debris ☐ Grease

Infiltration: **None** Pipe Seal Cond: **Unknown**

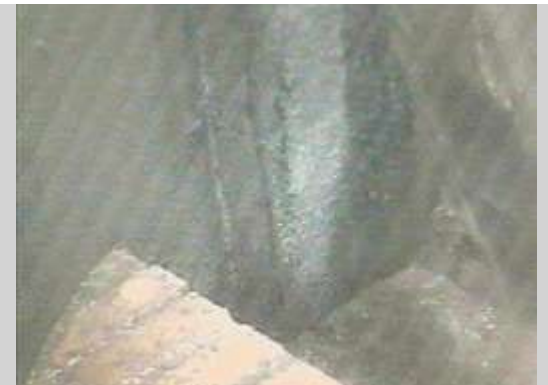
Pipe In @ 6 O'Clock

Pipe Material: ☐ Pipe Lined

Invert Depth: (ft.) Flow Characteristics: **None**

Infiltration: **None** Pipe Seal Cond: **Unknown**
